SIR JOHN
SOANE'S
MUSEUM
LONDON

CONSERVATION REPORT

OBJECT/FRAMED WORK	LOCATION	NUMBER
ANTIQUE STATUARY: BUSTS AND HEADS: Male Apollo Belvedere, plaster after antique	Lobby to Breakfast Room, north side	A76

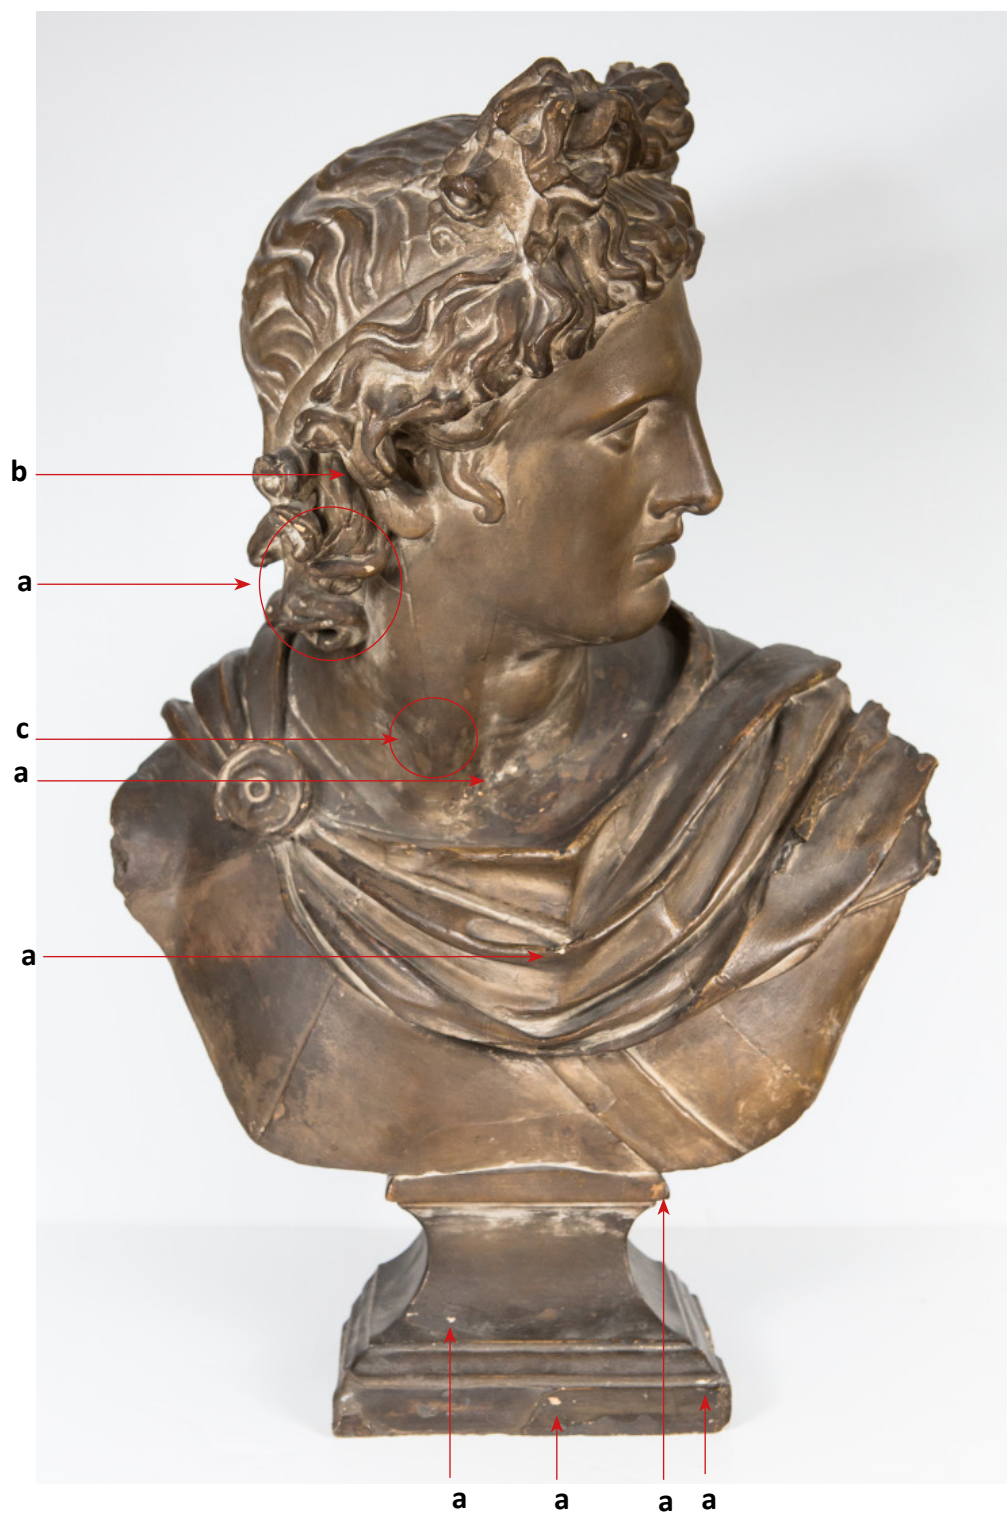
IMAGE OF OBJECT PRIOR TO TREATMENT FOR ANNOTATION (Front)

a	areas of missing paint layer
b	areas of lifting paint
c	steps in paint surface

The object had a thick layer of dust on all surfaces along with numerous abrasions. Areas of the paint surface were missing, leaving exposed areas of plaster. The largest area of loss was located on the proper left side of the base. Small areas of the paint surface throughout displayed signs of lifting (b), this was most visible on the chest area.

Certain areas of damage appear to have undergone retouching without fills, this has lead to visible 'steps' on the surface and delineations between different paint layers. These areas were present throughout and most visble were in Apollo's hair. Two holes are located on the back side at the base of Apollo's neck - a wire fixing has been inserted through these holes.

The object was given a dust with a fine pony hair brush and vacuum extraction. This was then followed by a saliva swab clean to remove ingrained deposits of dust and dirt.

Lifting and friable areas of paint and plaster were consolidated with Primal AC33 (8%). Areas to be filled were given a consolidation layer of Primal AC33 (4%) and then filled with Flugger to a level flush with the surrounding areas. Acrylic paint was used to tone in all fills (proper left base fill, before, during and after treatment, pictured below).

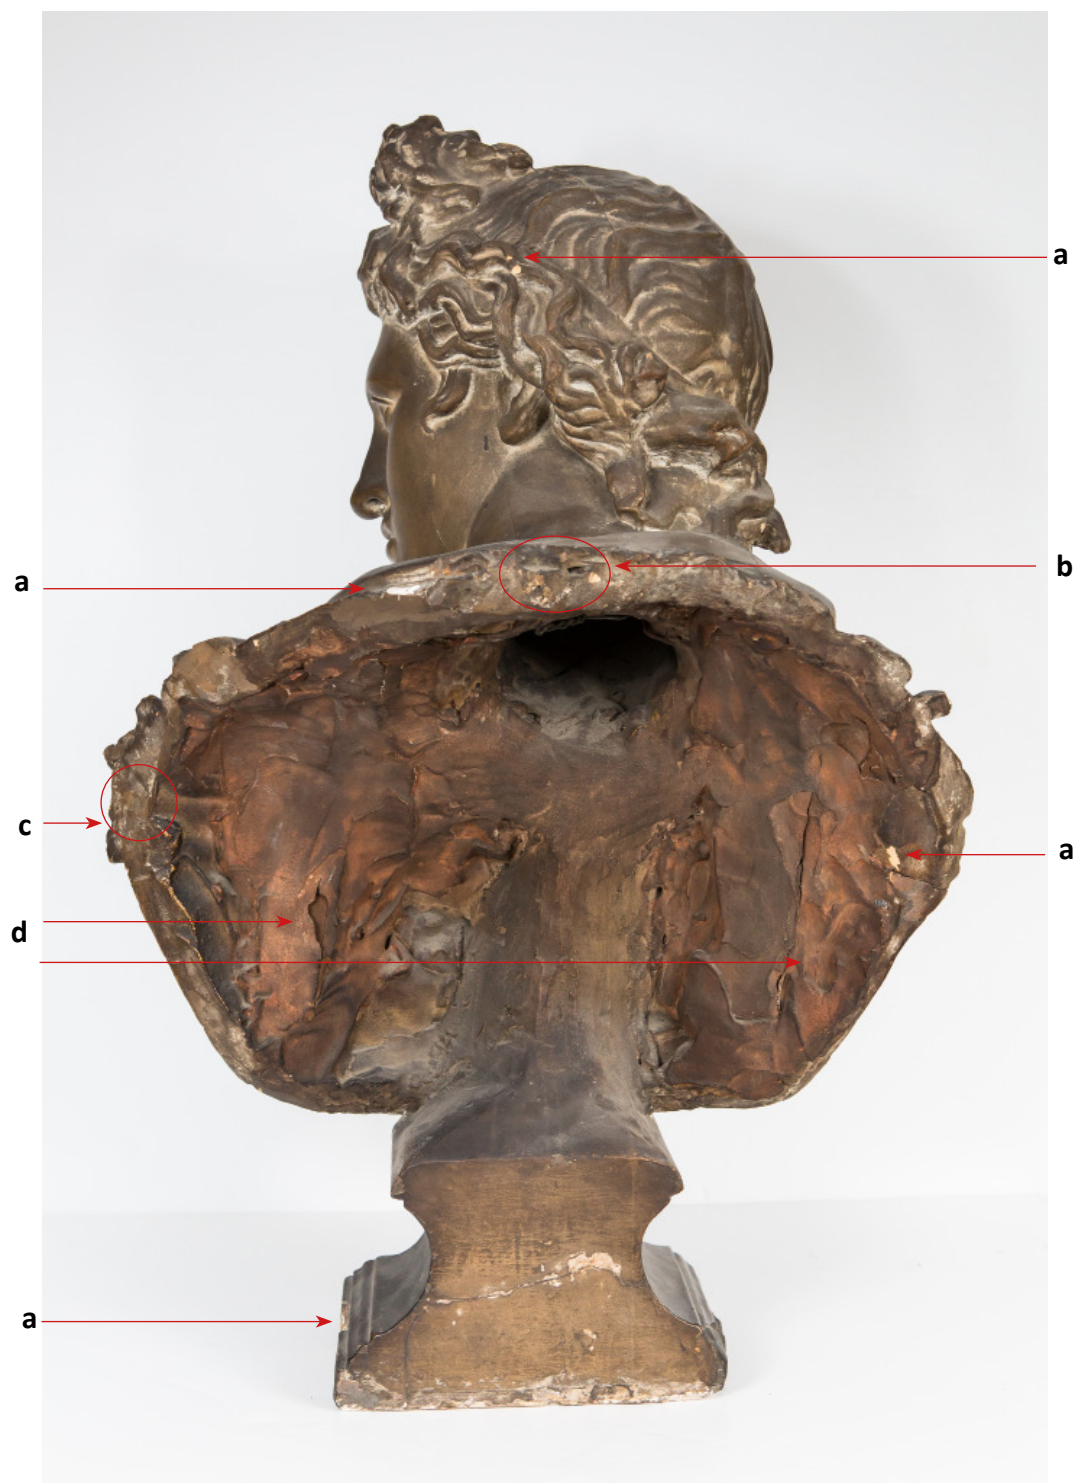
IMAGE OF OBJECT PRIOR TO TREATMENT FOR ANNOTATION (Back)

a	areas of missing paint layer
b	areas of lifting paint
c	steps in paint surface
d	metal armature staining

Sections of two metal armatures were visible on the back side. The Area around these has taken on a reddened appearance due to metal corrosion combined with the porous nature of the plaster. This dis-colouration has not shown itself through any of the paint layers.

The back underside of the bust displayed the largest amount of ingrained dust and dirt.

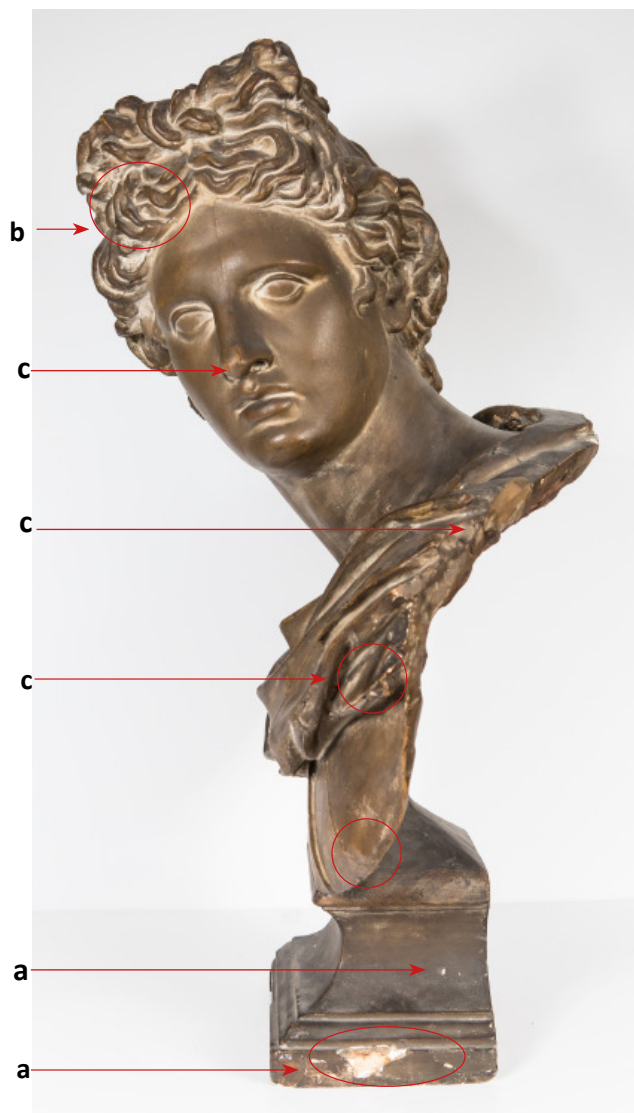
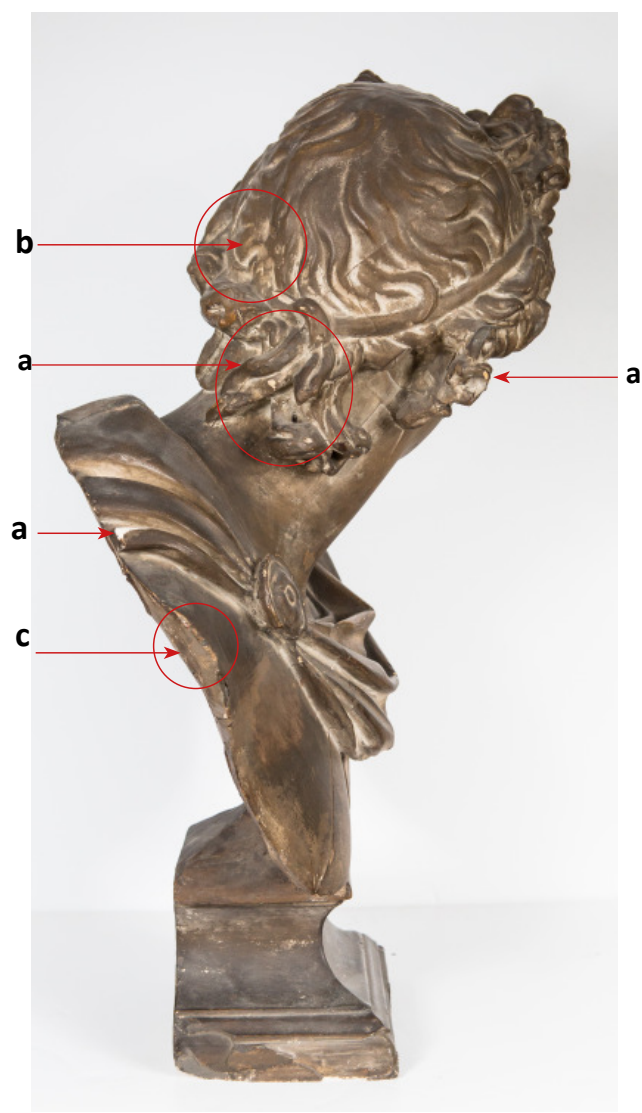
IMAGE OF OBJECT PRIOR TO TREATMENT FOR ANNOTATION (Left and Right)

a	areas of missing paint layer
b	areas of lifting paint
c	steps in paint surface
