CONSERVATION REPORT

OBJECT	LOCATION	NUMBER
DEC. SCUL.: ORNAMENT arabesque/scroll and birds, plaster, 16th C	Lobby to the Breakfast Room, South side	A3

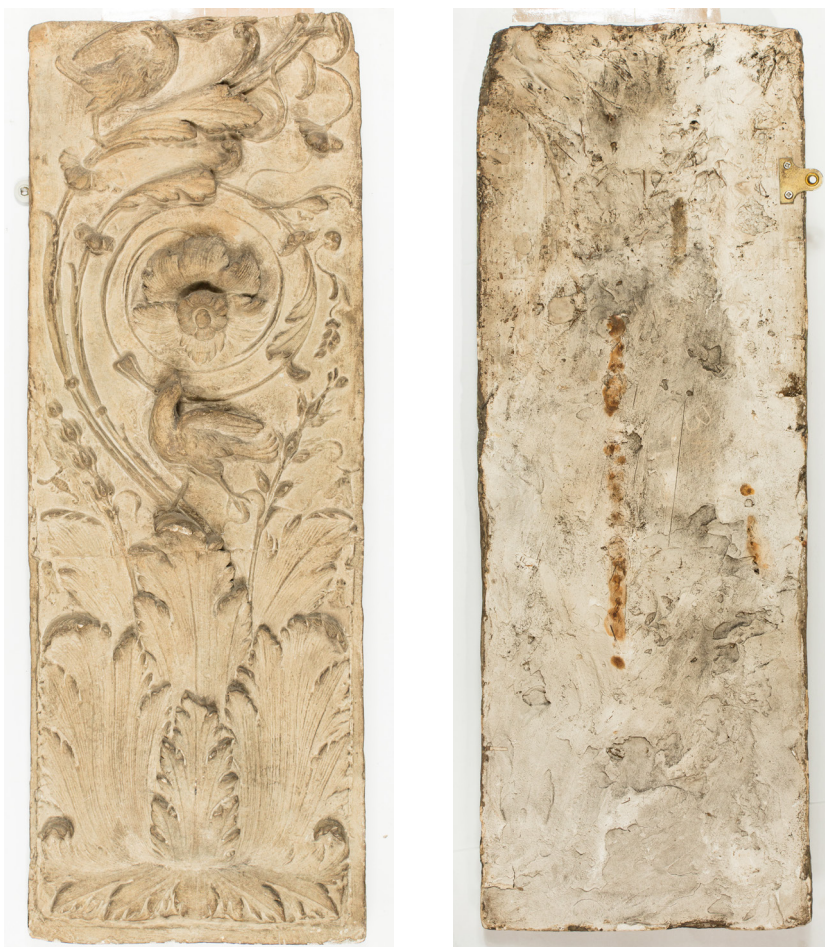
IMAGE OF OBJECT PRIOR TO TREATMENT (Recto & Verso)

Plaster relief panel with arabesque decoration. The surface of recto is painted with a distemper type paint (water sensitive) The surface on the recto has what appears to be a second layer of paint on the high areas of the relief, possibly to represent ageing. Over all surfaces is a thin layer of loose dirt. On verso there is evidence of organic material and possibly string embedded in the plaster perhaps as a form of strengthening. There are also rust stains indicating that there may be metal re-inforcement in the panel as well.

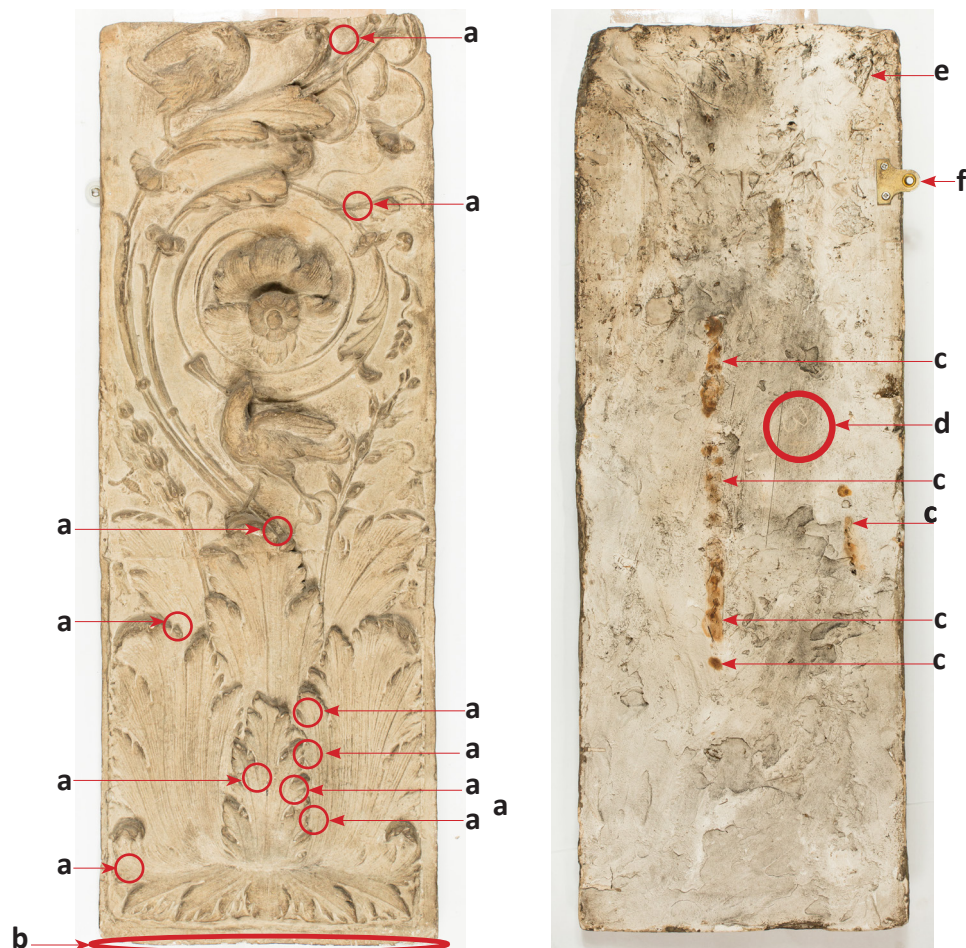
IMAGE OF OBJECT PRIOR TO TREATMENT FOR ANNOTATION (recto & verso)

a	Small losses to the surface of the paint and plaster
b	Abrasions and chips to edge of panel
c	Rust stains on verso
d	3 ANT scratched on verso
e	Example of organic material embedded in plaster on verso

f Modern mirror plate fixed on verso

There are some small areas of loss to the paint surface and plaster on the recto which are probably quite recent as they are visually noticeable and show the white plaster surface. **(a)**

All the edges of the panel have areas of flaking paint and abrasions at the edges. On the upper edge the loss to the surface is due to abrasion not flaking

There are rust stains visible on the verso of the panel which may indicate the presence of metal in the panel as a form of reinforcement **(b)**

All surfaces were first cleaned with a soft brush and a vacuum to remove loose dirt. The recto was then cleaned with swabs & saliva to remove further dirt

where there was loss and flaking to paint on the recto and edges the surface was consolidated with

Areas of paint loss and small damages to the cast were filled with layers of Flugger

Areas that were filled with Flugger were painted with acrylic paints to match the surrounding original paint surface
