CONSERVATION REPORT

OBJECT/FRAMED WORK	LOCATION	NUMBER
Portrait of Nathaniel Marchant RA	No. 13, South Passage, on the door to the Dressing Room	P27

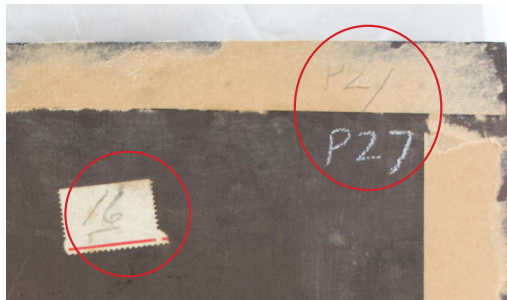
Existing numbering: **P27** in pencil on verso, **P27** in chalk on verso, **16** on paper label on verso

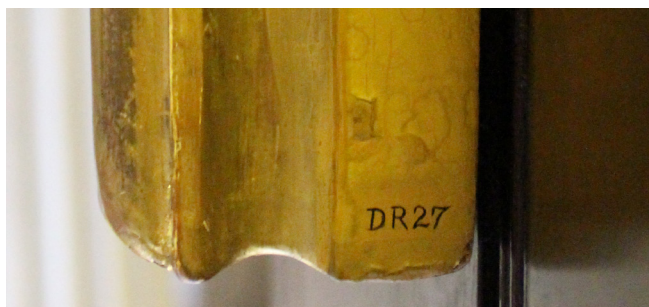
Application of museum number: **DR27** painted in black ink on bottom of proper left edge of frame

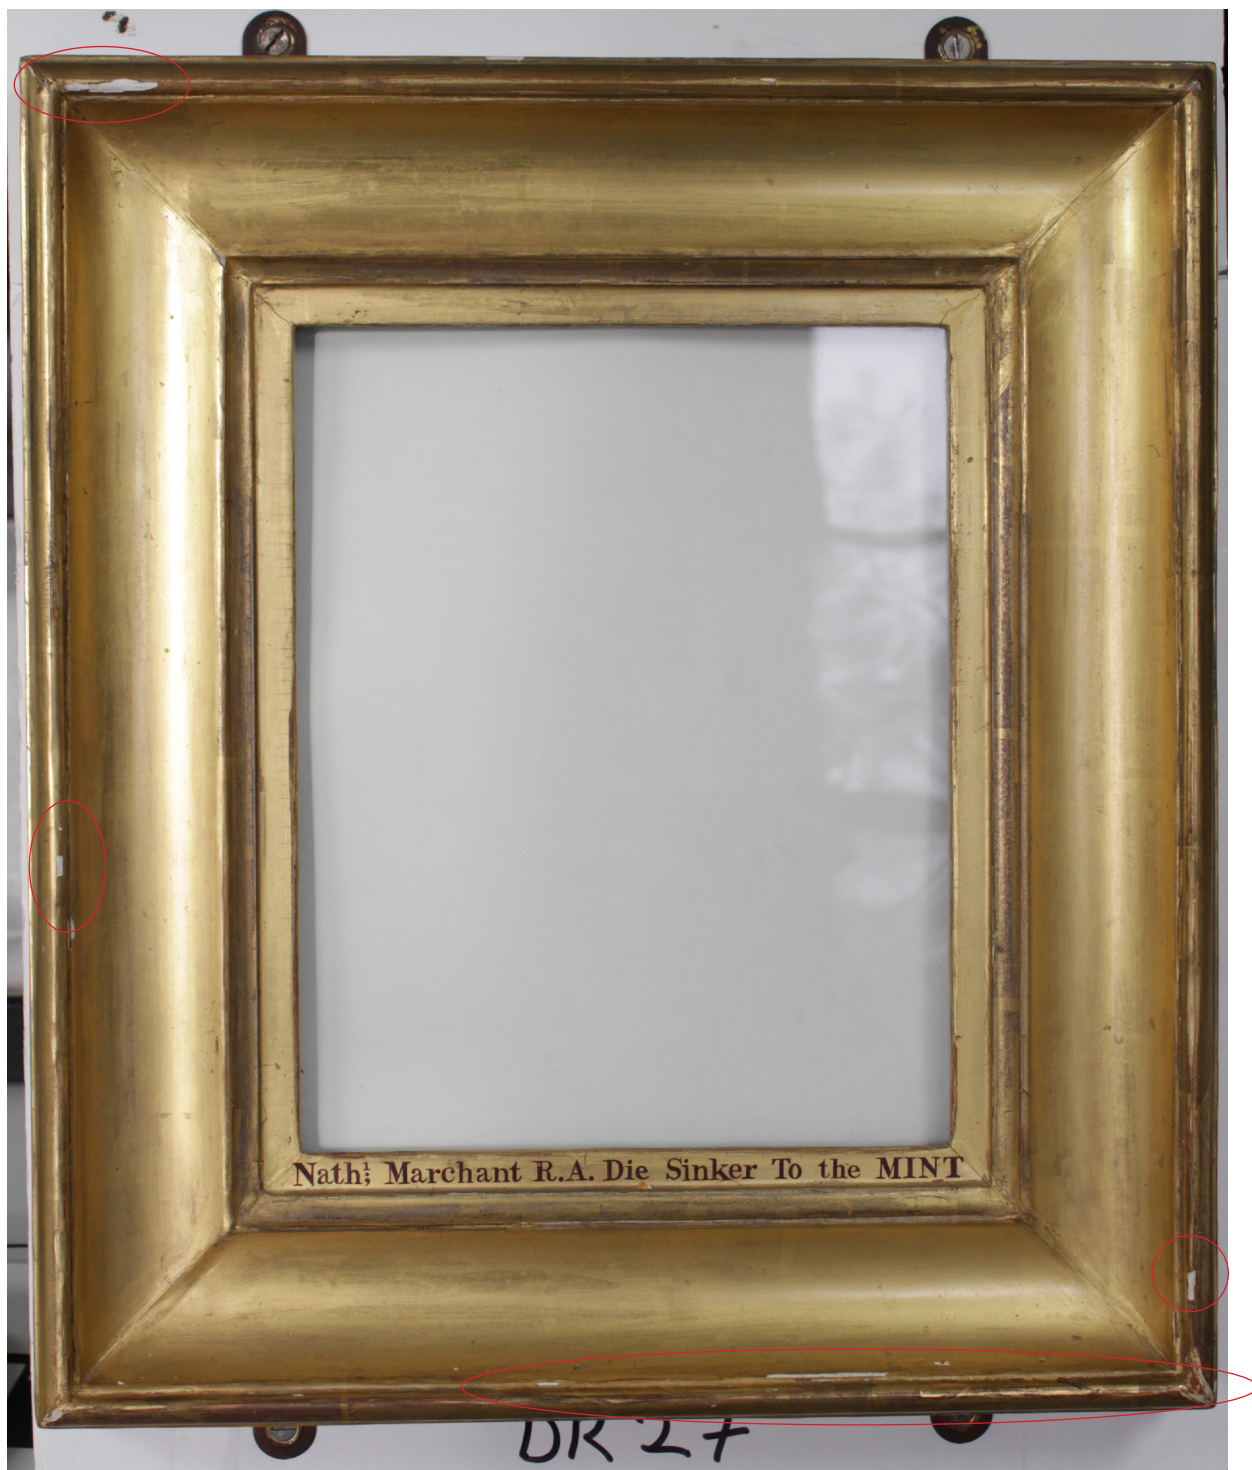
Frame: areas of loss to gilding around top edge, see image (a)

a Area of loss to gilding

Applied hot rabbit skin glue on losses in order to stabilise fragile gesso

All losses repaired with gesso putty

Orange-red clay applied to repairs, water gilded and toned to match existing gilding

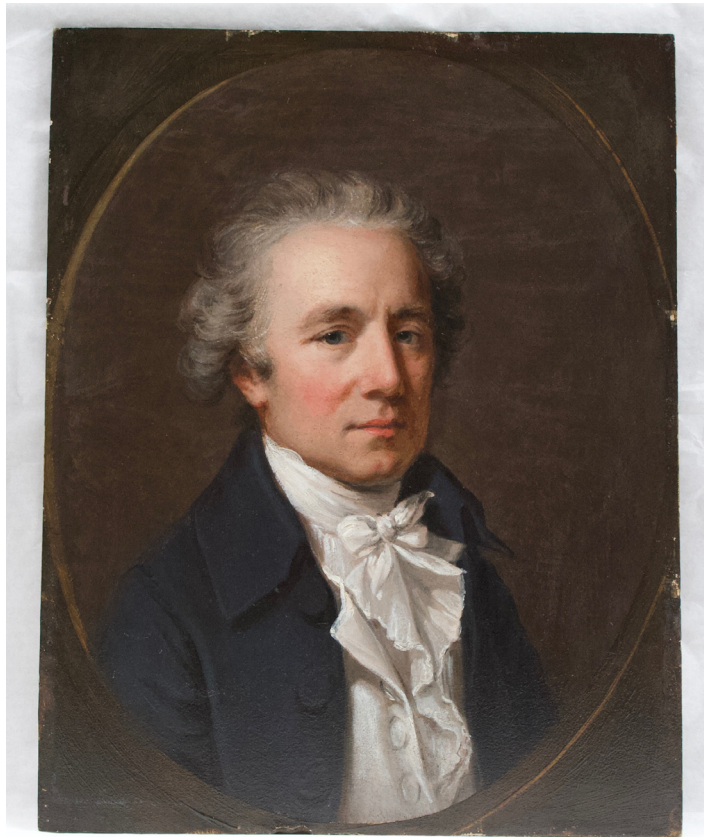
Work of art: in good condition but needs refitting

a Art work required refitting

Glazed with velvet ribbon on glass (extant). To provide cushioning for oil and very small air gap.

Panel too small in frame therefore rebate packed all round with strips of plastazote (extant).

A new sheet of micro chamber 2 ply board placed behind panel to protect old label.

A new thin sheet of plastazote added to pack behind panel (plastazote strips were deeper than panel)

A new sheet of 120 micron Melinex inserted as a barrier between the frame package and the new 3 mm mdf board. Chosen for rigidity, edges sealed with acrylic liquitex varnish to reduce VOC's.

Fitted with flexipoints and brown gummed paper tape.
