SIR JOHN
SOANE'S
MUSEUM
LONDON

CONSERVATION REPORT

OBJECT/FRAMED WORK	LOCATION	NUMBER
ANTIQUE STATUARY: BUSTS AND HEADS: Male Apollo Belvedere, plaster after antique	Lobby to Breakfast Room, north side	A76

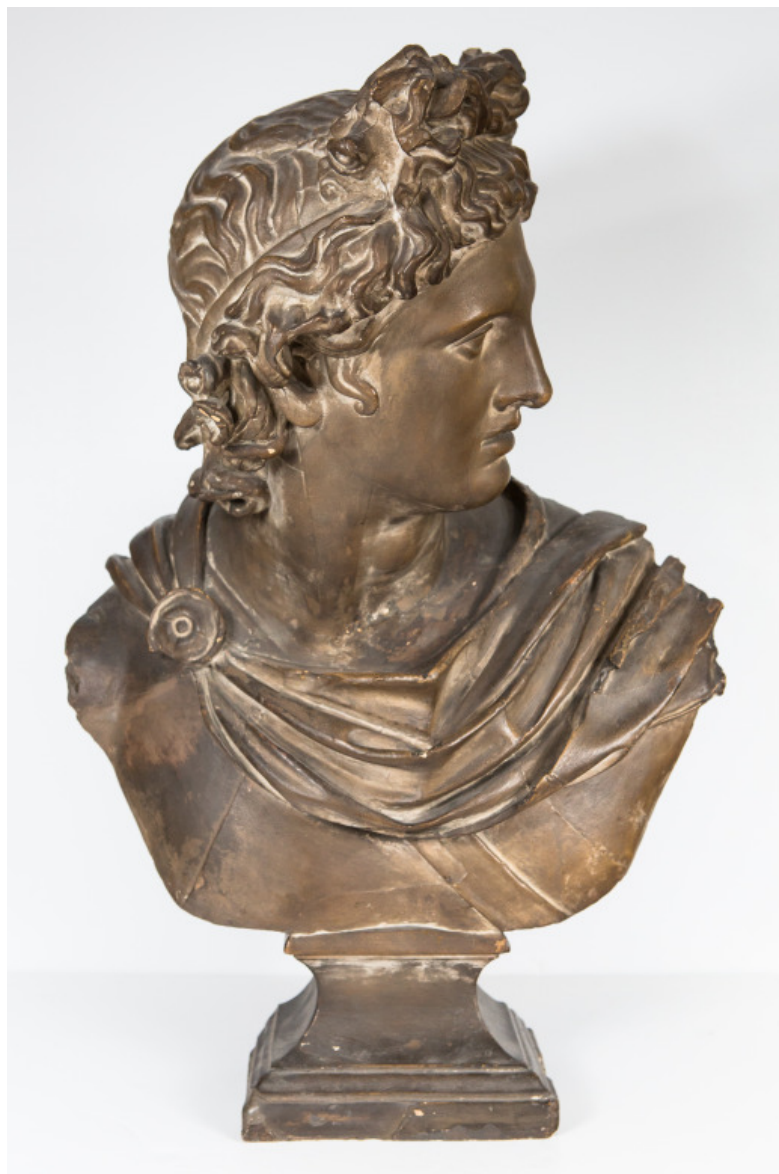
IMAGE OF OBJECT PRIOR TO TREATMENT (Front)

The object had a thick layer of dust on all surfaces along with numerous abrasions. Areas of the paint surface were missing, leaving exposed areas of plaster. The largest area of loss was located on the proper left side of the base. Small areas of the paint surface throughout displayed signs of lifting (b), this was most visible on the chest area.

Certain areas of damage appear to have undergone retouching without fills, this has lead to visible 'steps' on the surface and delineations between different paint layers. These areas were present throughout and most visble were in Apollo's hair. Two holes are located on the back side at the base of Apollo's neck - a wire fixing has been inserted through these holes.

Sections of two metal armatures were visible on the back side. The Area around these has taken on a reddened appearance due to metal corrosion combined with the porous nature of the plaster. This dis-colouration has not shown itself through any of the paint layers.

The back underside of the bust displayed the largest amount of ingrained dust and dirt.

The object was given a dust with a fine pony hair brush and vacuum extraction. This was then followed by a saliva swab clean to remove ingrained deposits of dust and dirt.

Lifting and friable areas of paint and plaster were consolidated with Primal AC33 (8%). Areas to be filled were given a consolidation layer of Primal AC33 (4%) and then filled with Flugger to a level flush with the surrounding areas. Acrylic paint was used to tone in all fills (proper left base fill, before, during and after treatment, pictured below).
