CONSERVATION REPORT

OBJECT/FRAMED WORK	LOCATION	NUMBER
Portrait of Nathaniel Marchant RA	No. 13, South Passage, on the door to the Dressing Room	P27

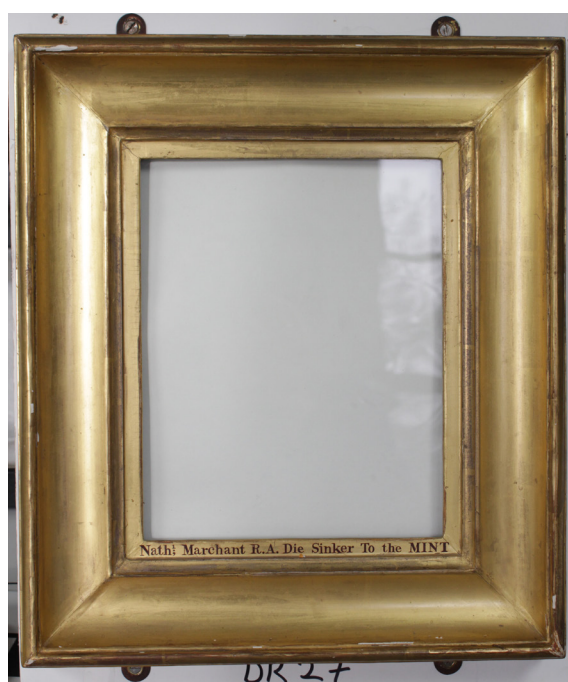
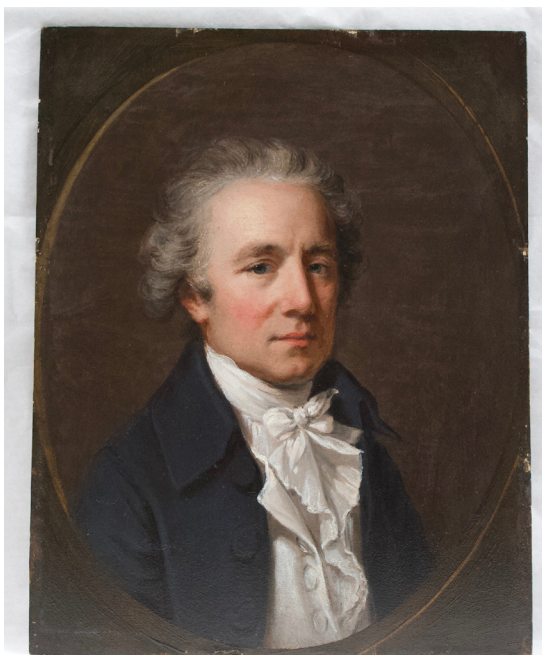
IMAGE OF OBJECT/FRAMED WORK PRIOR TO TREATMENT (Recto)

Frame: areas of loss to gilding around top edge, see image (a)

Work of art: in good condition but needs refitting

Applied hot rabbit skin glue on losses in order to stabilise fragile gesso

All losses repaired with gesso putty

Orange-red clay applied to repairs, water gilded and toned to match existing gilding
